UNITED STATES
NUCLEAR REGULATORY COMMISSION

Subject: COOPER NUCLEAR STATION - NRC SPECIAL INSPECTION
REPORT 05000298/2009008

IR 05000298/2009008; 02/23/09 – 05/12/09; Cooper Nuclear Station; Special Inspection into emergency diesel generator lubricating oil pipe cracking and Amphenol connector deficiencies

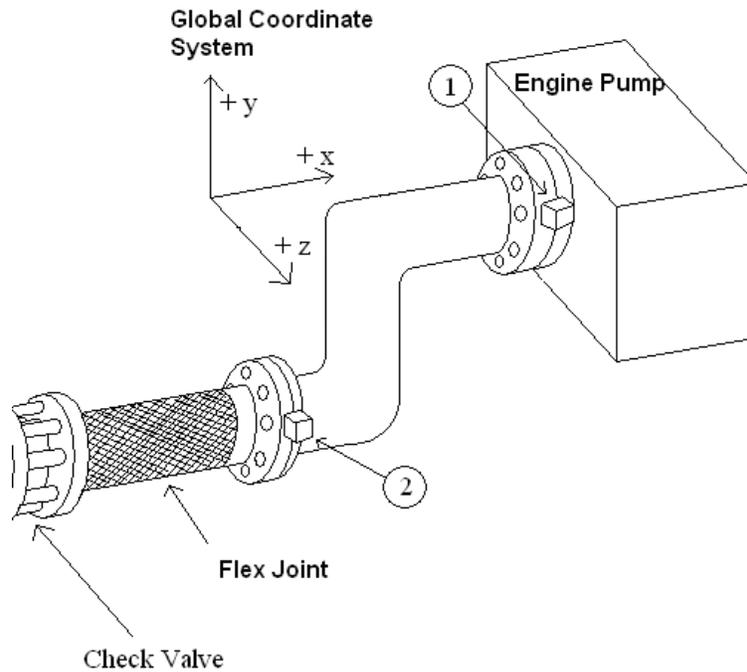
that caused the crack in the base metal resulted from vibration in the X-Direction (axial to the metal flexible hose and perpendicular to the crack face).

Figure 1: Lube Oil S-pipe with Flex Joint Showing X-, Y-, and Z-Direction(s)

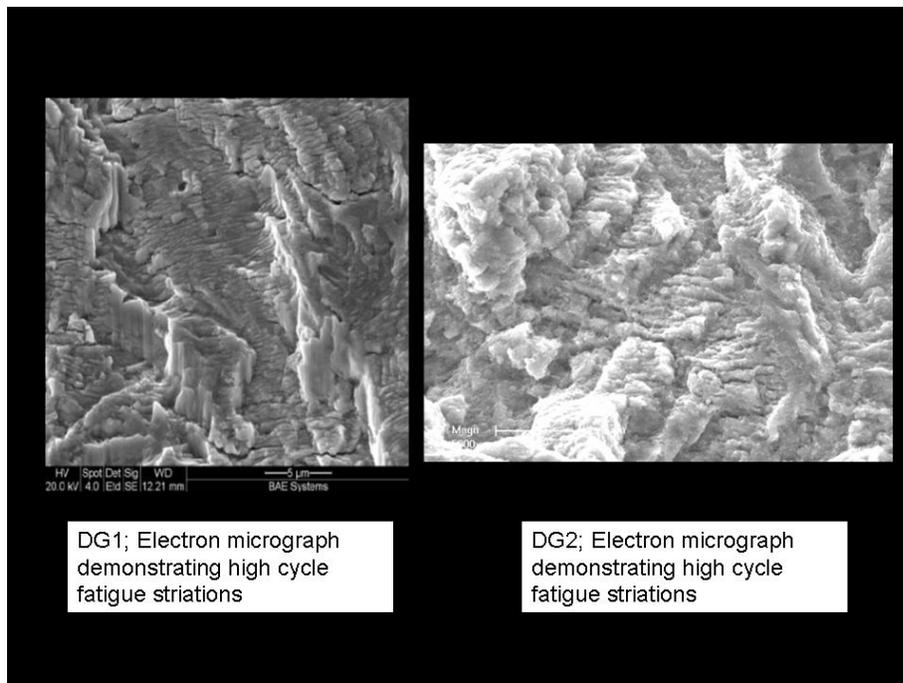
During December 2008, NRC challenged the licensee on their root cause evaluation because of the discrepancies in their conclusions compared to the documented metallurgical results that indicated high cycle fatigue in the Southwest Research Institute report. The fracture surface appearance did not suggest ductile tearing. Ductile tearing is typically presented by dimple, or cup and cone fracture appearance both macro and microscopically. The Southwest Research Institute report clearly showed the surface

was flat and smooth with clear evidence of beachmarks and striations indicative of a high cycle fatigue failure mechanism (refer to Figure 2). The licensee initiated Condition Report 2009-00098 to resolve the NRC concerns related to misdiagnosis of the failure mechanism for the Emergency Diesel Generator 2 lubricating oil discharge S-pipe crack.

Figure 2: Comparison of Microstructure Evidence from the Emergency Diesel Generators 1 and 2 Lube Oil Pipe Crack fracture surfaces

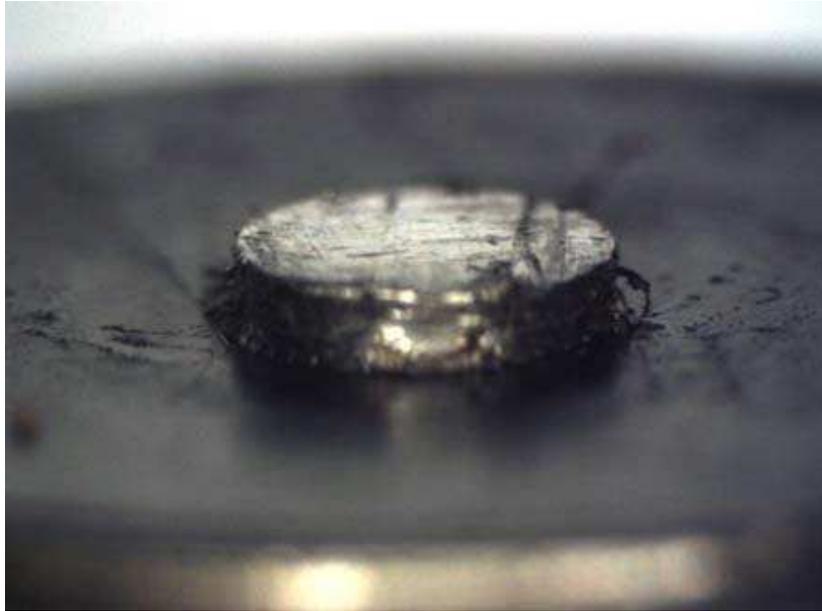
Figure 3 - Closeup of Magnetic Pickup Unit

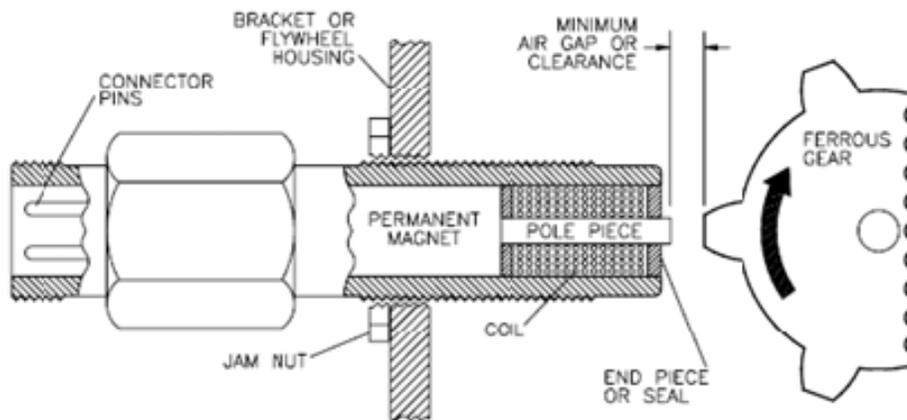
Figure 4: Typical Magnetic Pickup Arrangement

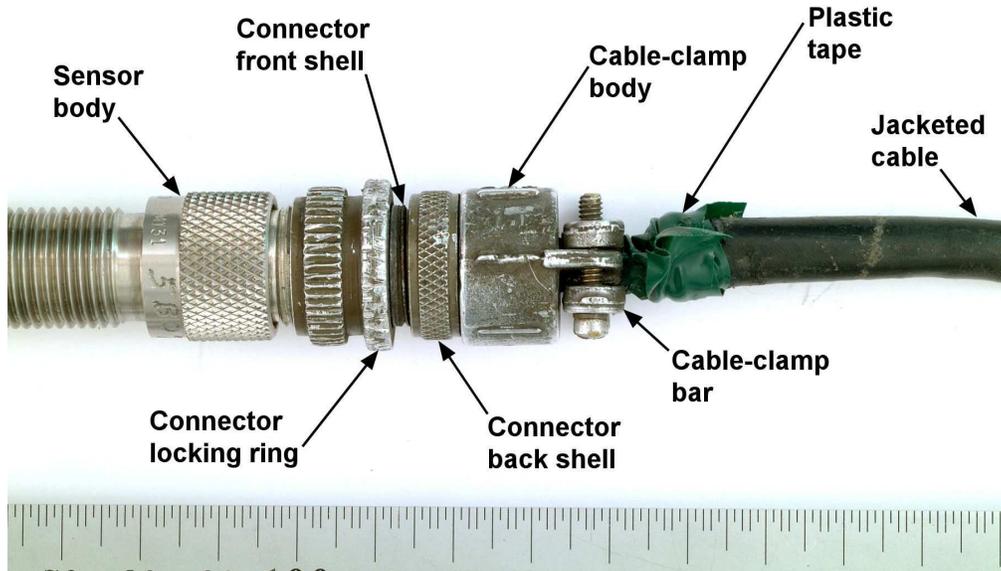
Figure 5: Inappropriate use of tape

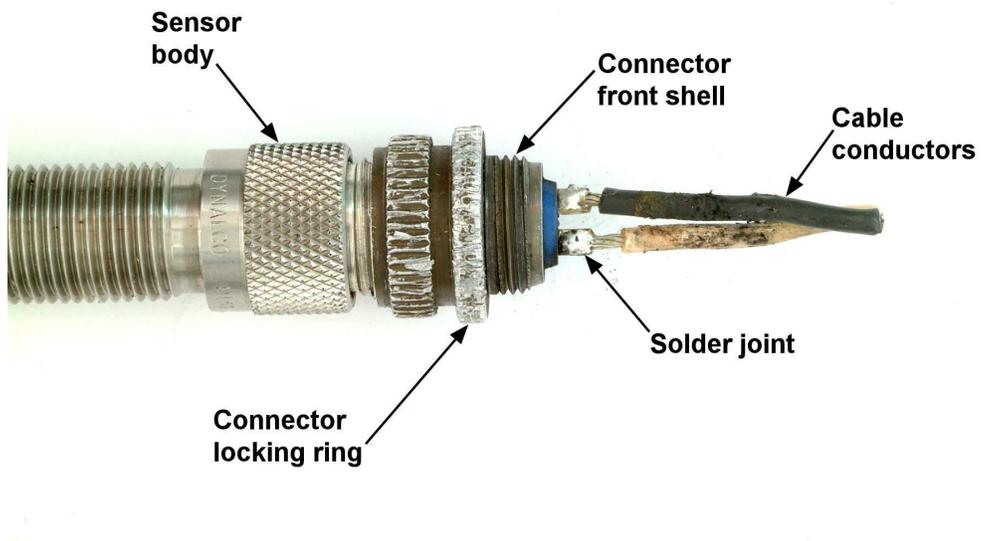
Figure 6: Photograph of poor solder connection

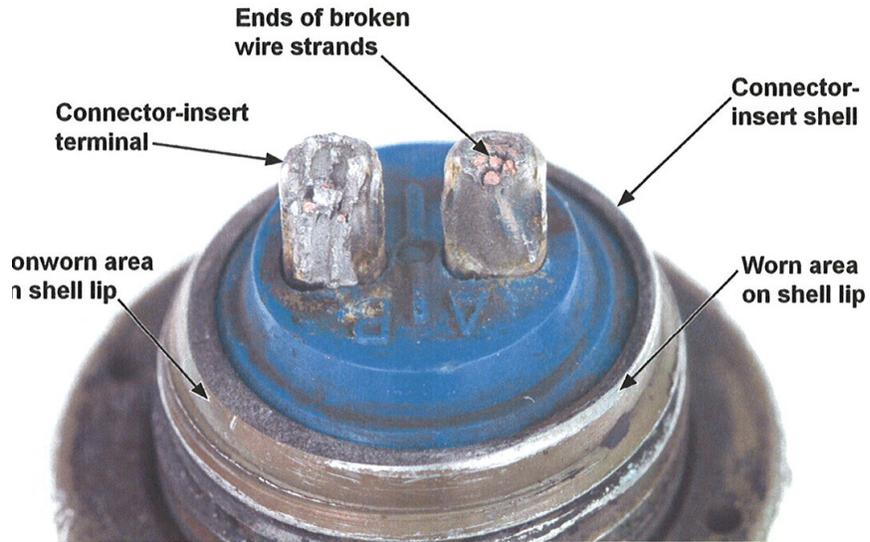
Figure 7: Poor Solder Connection

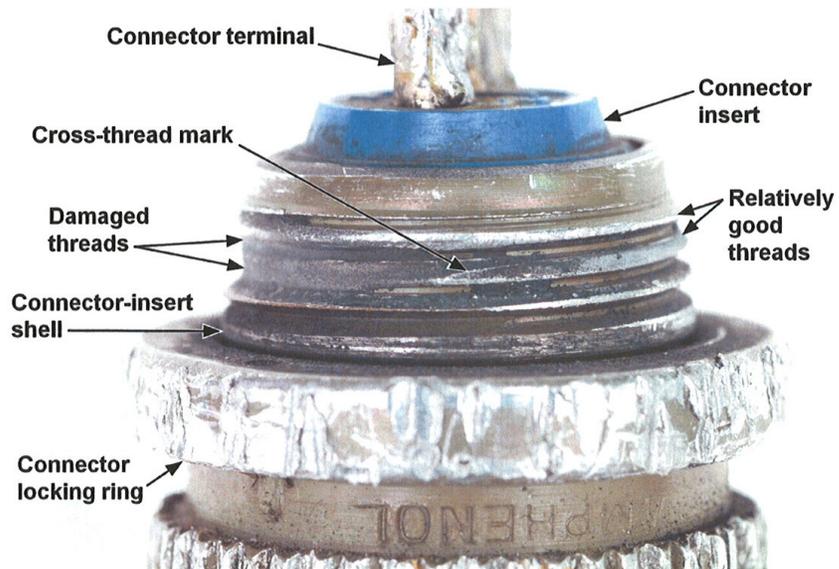
Figure 8: Cross-threaded Back Shell
