UNITED STATES
NUCLEAR REGULATORY COMMISSION

SUBJECT: CATAWBA NUCLEAR STATION – SPECIAL INSPECTION REPORT
05000413/2006010 AND 05000414/2006010

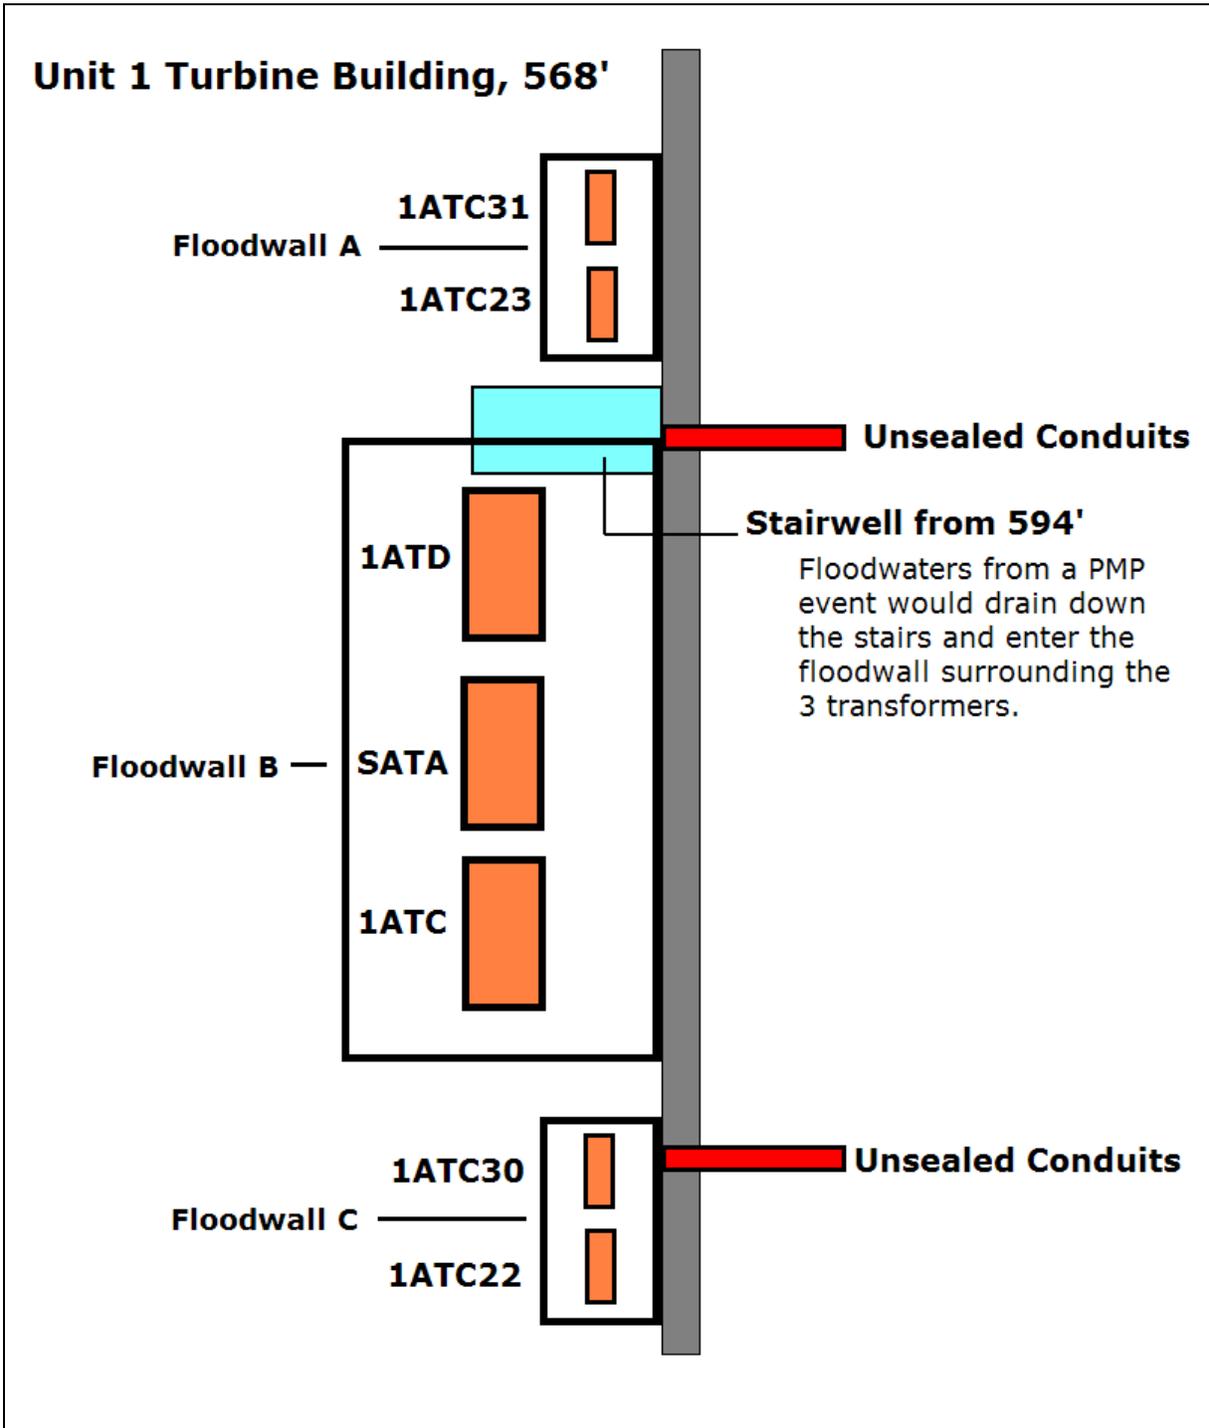
UNIT 1

There are three (3) floodwall enclosures in each unit's turbine building basement designed to protect transformers 1ATC, 2ATC, 1ATD, 2ATD, SATA and SATB along with their associated terminal cabinets 1ATC22, 2ATC22, 1ATC23, 2ATC23, 1ATC30 and 1ATC31. The floodwalls were constructed to reduce the PRA model's risk that resulted from a postulated break of a pipe within the turbine building and subsequent loss of these components. The following summarizes what the impact could be on station operation if one of these components was lost due to flooding. Attachment 9 contains drawings showing the floodwalls for each unit, what equipment is enclosed by each and the water ingress flow paths that existed prior to their repair in September 2006.

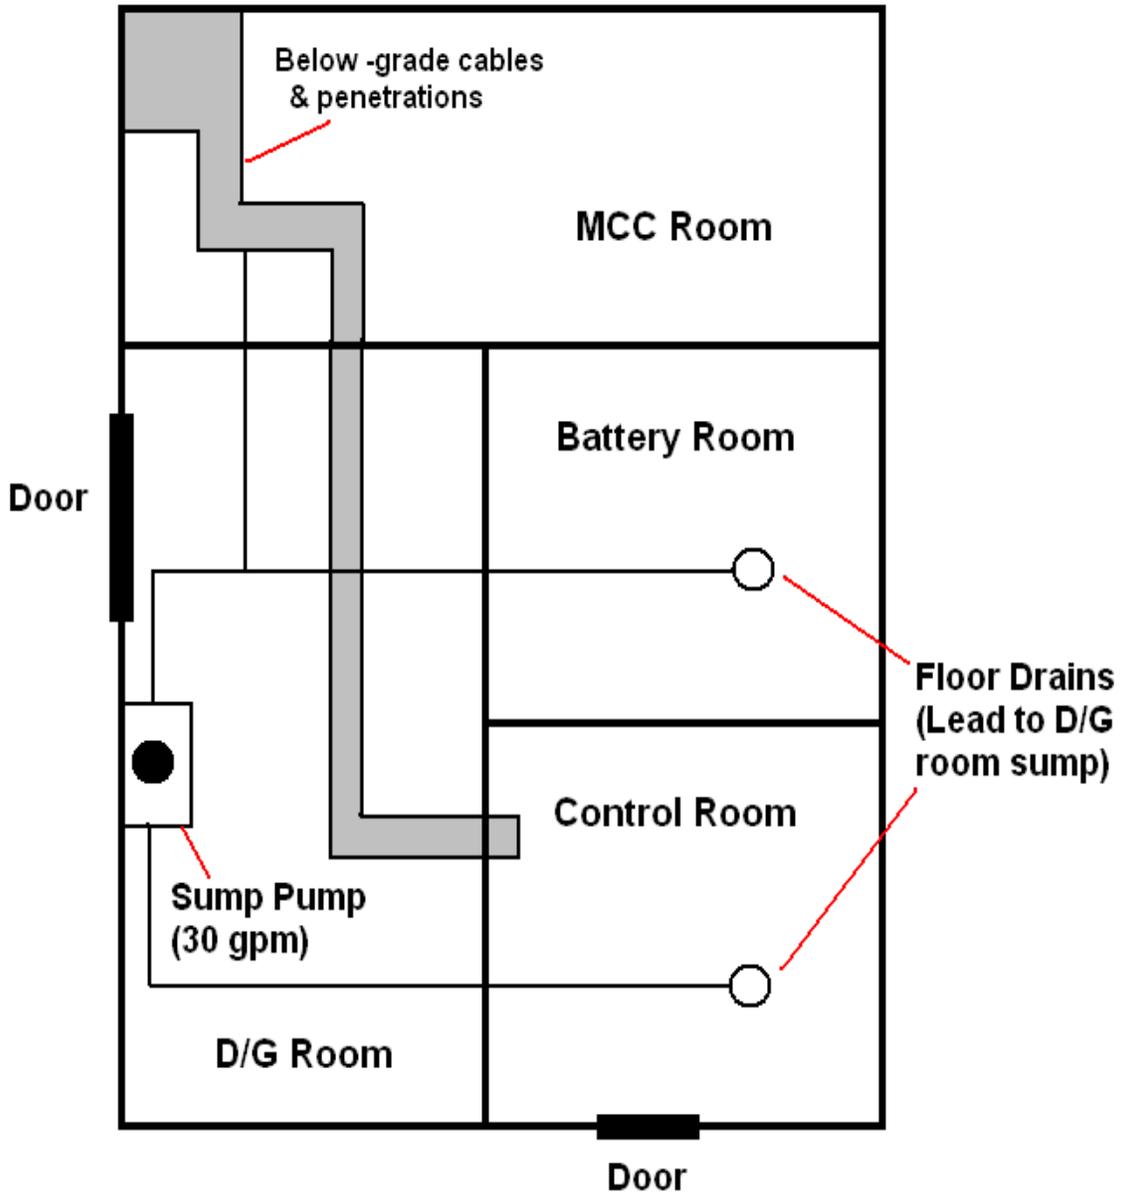
Standby Shutdown Facility - Catawba Nuclear Station

During the week of October 20, 2006, an NRC inspection identified that below-grade electrical conduit penetrations entering the SSF were not adequately sealed to prevent water in-leakage in the event the cable trench filled with water. Additionally, the

inspectors determined that water could enter the SSF during a PMP flooding event through the building's two doors and diesel room ventilation panels. The degraded conduit seals had not been inspected following either of the two previous 2006 flooding events due to the licensee failing to recognize the risk-significance of the SSF. The fact that the SSF would be rendered inoperable in the event of a PMP was not identified by the licensee following the revision of the calculated PMP flood level because the SSF is not designed to be a safety-related structure and site engineering personnel did not recognize the risk significance that the SSF had in terms of the Catawba PRA model.

NOTE: The floor elevation of the SSF is at 594' above Mean Sea Level (MSL). The PMP flood level at Catawba is currently 594' 9" above MSL.
