UNITED STATES
NUCLEAR REGULATORY COMMISSION

Subject: DIABLO CANYON POWER PLANT - NRC SPECIAL INSPECTION
REPORT 05000323/2009009

NRC Inspection Report 0500323/2009009

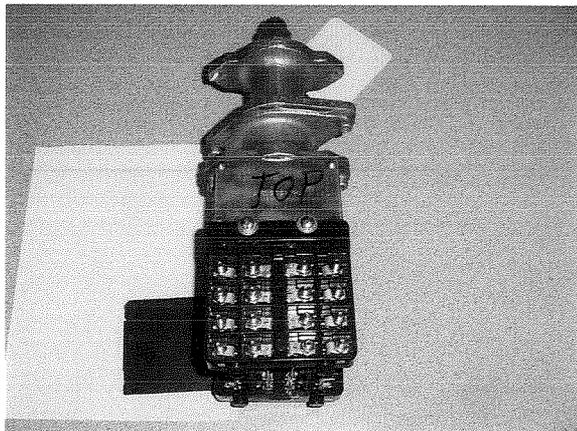
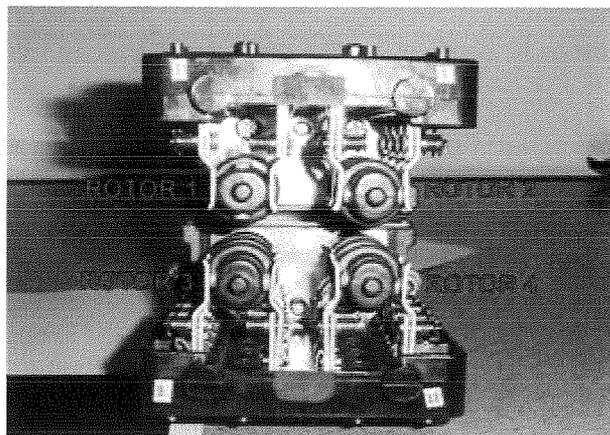
Attachment 6: Limit Switches

Description: On February 16, 2008, a plant engineer specified that the stroke length of RHR containment sump Valves SI-2-8982A/B be reduced from 15.5 to 13.8 inches. The manner in which this change was implemented disabled the emergency core cooling system permissive that allowed remote manual operation of Valves CS-2-9003A/B and Valves SI-2-8804A/B. The reduced sump valve stroke length also resulted in a portion of the valve disc to protrude into the system flow path, degrading the available net positive suction head to the RHR pumps. The inspection team identified that the plant engineer failed to meet plant design configuration control requirements as specified in Drawing M000073. This drawing required plant Design Engineering personnel to review the affected calculations and the Plant Test Group to scope applicable testing to demonstrate that the component would perform as required prior to retuning the sump valves to service. Because the design control process was circumvented, the stroke length was not verified by independent personnel nor was the modification evaluated against other design requirements. The loss of remote manual operation of Valves SI-2-8804A/B rendered the emergency core cooling system inoperable. Further, the shortened stroke length resulted in the valve disc occluding the valve flow area, reducing the available net positive suction head.

Improper coordination of limit switches on Unit 2 residual heat removal (RHR) sump suction Valves SI-2-8982A/B resulted in the disablement of interlocks which permit operators to open the valves that provide RHR flow to the suction of the safety injection and charging pumps (SI-2-8804A/B). This resulted in a loss of the capability for operators to initiate cold leg recirculation from the control room for loss of coolant accidents that do not depressurize the reactor coolant system below the shutoff head of the RHR pumps. The valves were accessible and could have been re-positioned locally.
