SUBJECT: BYRON STATION, UNITS 1 AND 2  
FOLLOW UP INSPECTION OF AN UNRESOLVED ITEM (URI)  
05000454/2008008; 05000455/2008008

Report Nos: 05000454/2008008; 05000455/2008008

Facility: Byron Station, Units 1 and 2

##### .1 (Closed) URI 05000454/2005002-06; 05000455/2005002-06: Concerns With Single Failure Assumptions

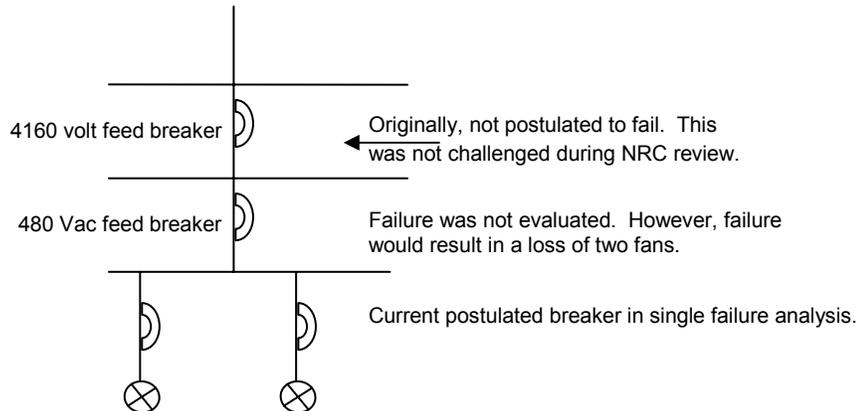
During the 2005 NRC safety systems design and performance capability inspection, the inspectors noted that in Technical Specification (TS) Amendment No. 95 for Byron Station (changes to the ultimate heat sink to support steam generator replacement), the most limiting single failure evaluated was the failure of active breakers or switches in the 480 Vac service water cooling towers (SXCT) bus which resulted in the failure of one service water cooling tower fan. The inspectors noted that the licensee did not address the 480 Vac feed breakers between the 4160/480 Vac transformer and bus 131Z (for example). The inspectors also noted that a single failure of either of the breakers would de-energize the bus and result in a loss of two service water cooling tower fans. See below for an illustration of the configuration.

The licensee disagreed, stating the breakers were normally closed and therefore, a passive failure need not be considered.

The issue was unresolved pending determination on whether the loss of the 4160 feed breaker should have been considered as the single failure.

Consistent with the definition of a single failure presented in 10 CFR Part 50, Appendix A, and General Design Criterion 44, the spurious failure/opening of the 4160 volt or 480 Vac should have been considered a valid single failure and assessed. In reviewing the licensee's Amendment No. 95, the NRC did not evaluate the potential for a passive failure of the electrical breakers even though passive failures were required to be evaluated under 10 CFR Part 50, Appendix A.

The inspectors and members of the Electrical Branch in NRR discussed the conclusions and the need to be in compliance with the licensee. The licensee initiated corrective actions 00711704 and 663350. To compensate for the nonconforming condition, the licensee continued implementing an administrative control to allow only one fan out of service (OOS), compared to two allowed by TS. By allowing only one fan OOS, the licensee maintains the required five fans needed to mitigate their design basis accident (LOCA concurrent with LOOP in one unit and LOOP in the other unit), assuming the remaining two are lost due to the single failure of the breakers.

In addition, the licensee plans to reanalyze their design basis which may require a TS change to increase the number of UHS fans required to be operable from six to seven. Consequently, the licensee invoked the provisions of NRC Administrative Letter (AL) 98-10, "Dispositioning of Technical Specifications That Are Insufficient to Assure Plant Safety" until such time the TS are revised or an engineering analysis demonstrates six fans are still acceptable for operability.
