**UNITED STATES  
NUCLEAR REGULATORY COMMISSION**  
REGION IV  
1600 E. LAMAR BLVD.  
ARLINGTON, TX 76011-4511

February 13, 2015

**SUBJECT: ARKANSAS NUCLEAR ONE – NRC INSPECTION REPORT 05000313/2014005  
and 05000368/2014005**

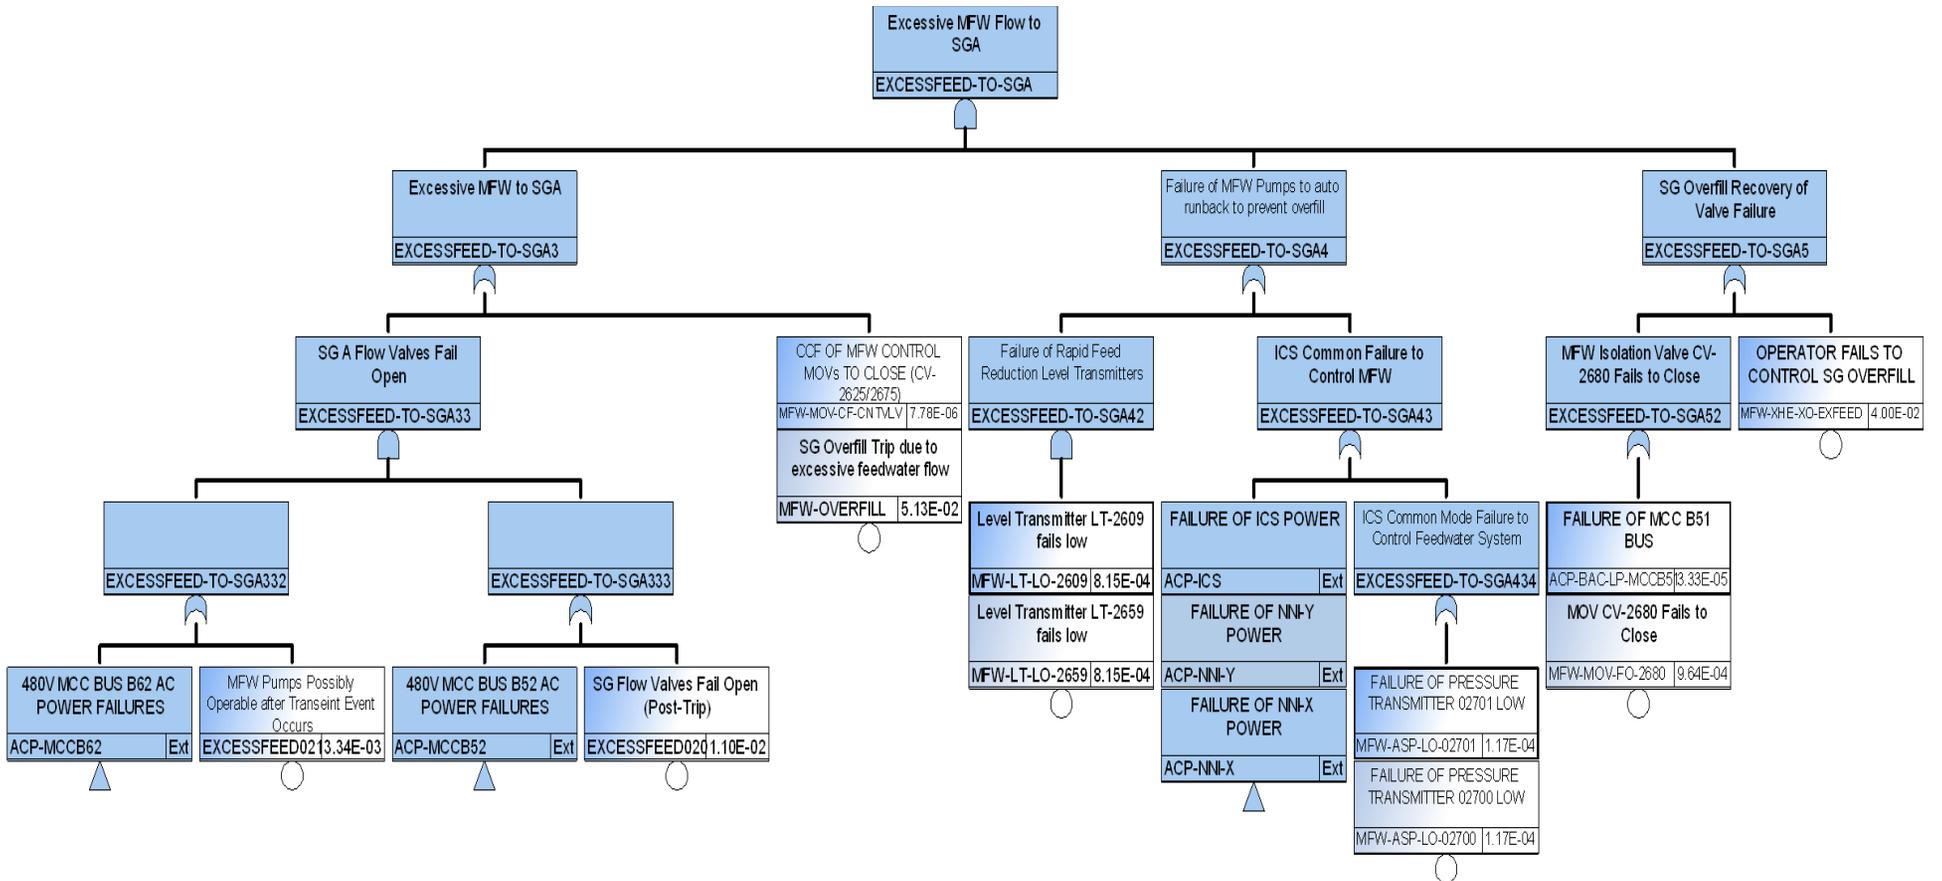
3. Adjustment of value for Excess Feed of the Steam Generators. Basic Events MFW-SYS-FC-EXFEEDA, "Main Feedwater System Excessively Feeds Steam Generator A," and MFW-SYS-FC-EXFEEDB, "Main Feedwater System Excessively Feeds Steam Generator B," were adjusted. After review of the design and operation of the ANO Unit 1 main feedwater system and its response during postulated events, the analyst determined that the existing SPAR model overestimated the probability of excessively feeding the steam generators. The analyst constructed new fault trees to better estimate the probability of excessive feeding the steam generators taking into account the system design and operation. The new fault tree used for Steam Generator A (which is functionally the same as the new fault tree for Steam Generator B) is depicted below.
