**UNITED STATES  
NUCLEAR REGULATORY COMMISSION**

**SUBJECT: BRAIDWOOD STATION, UNITS 1 AND 2, NRC SPECIAL INSPECTION TEAM  
(SIT) REPORT 05000456/2010010; 05000457/2010010**

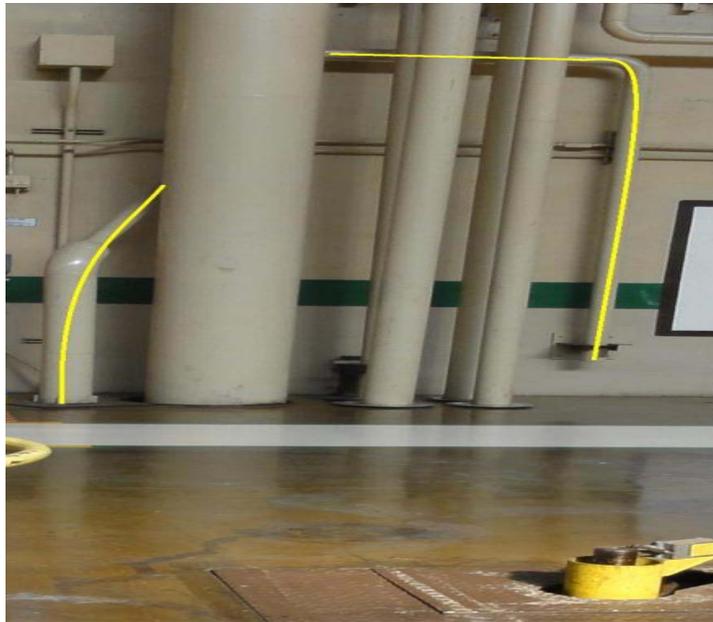
When Unit 2 tripped on August 16, 2010, the condenser hotwell level began to rise and reached the setpoint to actuate hotwell overflow control valves. For approximately 15 minutes, the flow rate of water rejected from the hotwell to the CST was greater than the discharge rate out of the AFW pumps. Therefore, during this time, water was discharged from the two Unit 2 AFW stand-pipes to the turbine building floor at

the 451' elevation. The turbine building is shared between the two units. The licensee roughly estimated that 12,000 gallons of water discharged through the stand-pipes. This volume of water flowed down onto the lower elevations of both units through nearby floor openings.

**Photograph 1 – One of two Unit 2 suction header stand-pipes**

Water entered MCC 133V and caused feed breaker 1435V to trip. The loss of MCC 133V resulted in the loss of 1A and 1C CW pumps, which led to a Unit 1 automatic reactor trip on low condenser vacuum approximately 13 minutes after Unit 2 tripped.

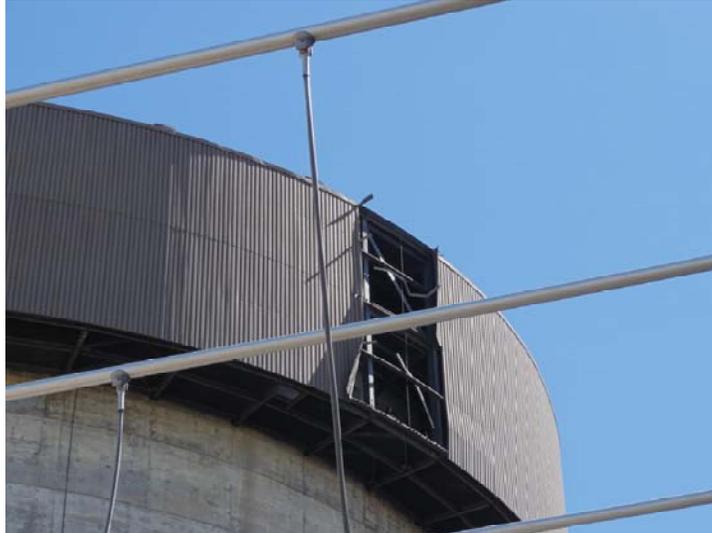
The team reviewed the circumstances surrounding the Unit 1 reactor building flashing that was dislodged during the steam release from the MSSVs (see Photograph 2). This review included identifying the reason the flashing was dislodged, evaluation of past similar events, and assessing the impact of the falling flashing to the Unit 1 transformers, and corrective actions taken by the licensee.

**Photograph 2– Area where flashing was dislodged from Unit 1 containment**

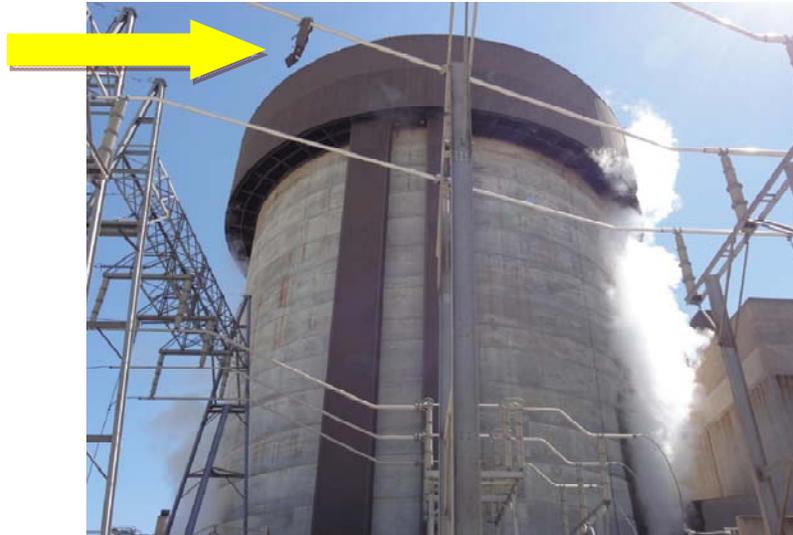
Description: On August 16, 2010, the unit 1 CW pumps 1A and 1C tripped and caused condenser vacuum to degrade. Operators initiated a turbine runback but vacuum continued to degrade until the turbine automatically tripped followed by reactor trip. The C-9 permissive, which would normally open the steam dump valves, was disabled due to failure of MCC 133V. Without the steam dump valves, the PORVs open to control temperature and pressure. In addition, two or three of the MSSVs open and subsequently close, with the exception of one which remains open. All of these valves release excess steam to the environment. The steam released from the combination of the PORVs and MSSVs caused portions of the containment flashing, located above the vent lines for these valves, to become detached and land on power lines and in the area of the off-site power transformer and equipment (See Photograph 3).

**Photograph 3 – Flashing dislodged from Unit 1 containment located on main power transformer output lines**

On August 11, 1994, Braidwood Unit 1 experienced a spurious train “A” main steam isolation followed by an automatic reactor trip. Unit 1 PORVs and MSSVs lifted causing some flashing and a piece of the containment roof walkway to become dislodged piercing the turbine building roof. At the time, site engineering staff visually inspected the main steel framing and flashing for the containment walkway enclosure and determined that no structural damage had occurred. All sections of sheet metal siding blown off the walkway were accounted for and were placed in storage for future evaluation. The flashing and walkway were replaced.
