UNITED STATES
NUCLEAR REGULATORY COMMISSION

SUBJECT: FORT CALHOUN STATION- NRC COMPONENT DESIGN BASES INSPECTION
REPORT 05000285/2009006

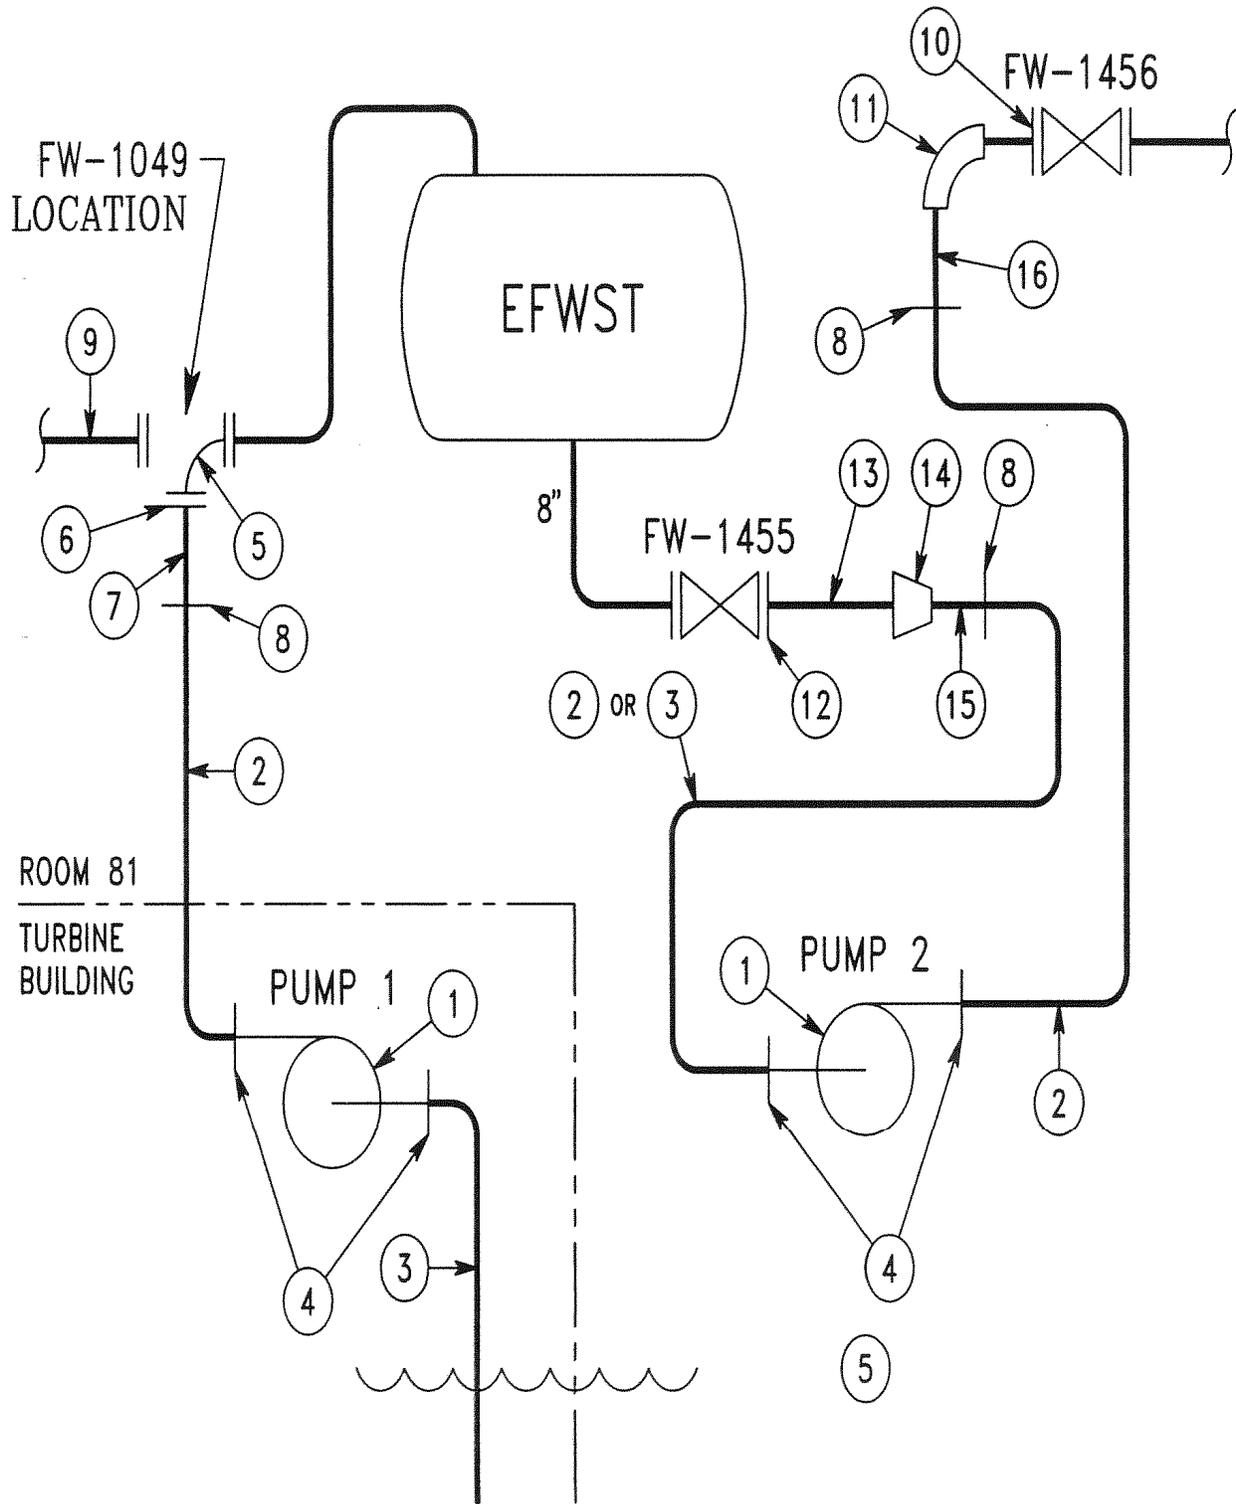
Figure 1

Procedure PE-RR-AE-1002 directs the installation of two portable gasoline engine-driven pumps as shown in the drawing in Figure 1. The first pump takes a suction directly on the flood waters in the turbine building via a suction strainer and fills the Emergency Feedwater Storage Tank via fire hoses and a permanently installed process flange. The second pump takes a suction from the tank via a second flange, and pumps to the steam generators through hoses, fittings, and flanges to the feedwater system.

The analyst utilized information available in Westinghouse LTR-RAM-II-09-085, "Reliability Analysis of Refilling the EFWST Using Portable Gasoline Pumps," to create the fault tree shown in Figure 1. The analyst used the failure data from Westinghouse LTR-RAM-II-09-085 as the best estimate parameter values. For Basic Event EFW-XHE-PORTABLE, "Operators Fail to Makeup to S/Gs using Gasoline Pumps," the analyst used the SPAR-H method for human reliability analysis.

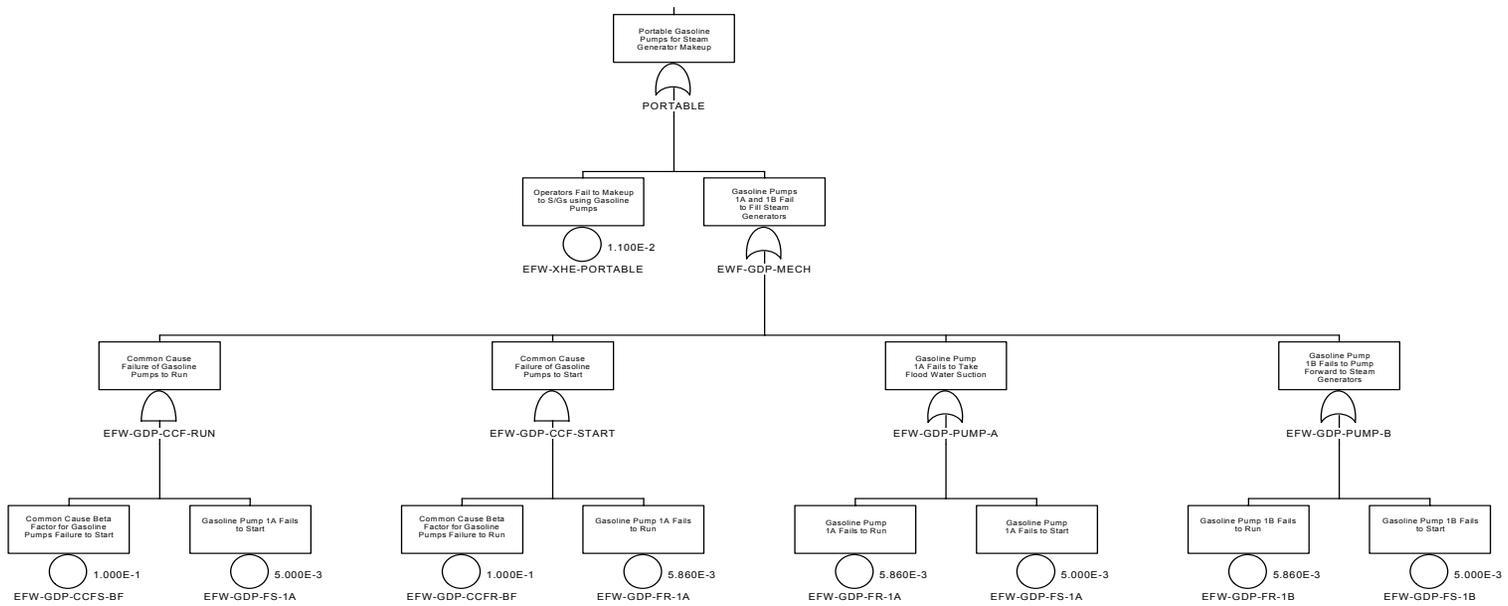
Figure 2

The analyst solved the fault tree, shown in Figure 2, and determined that the probability that this alternate mitigation strategy would fail was 3.23E-02. Because this strategy would be available regardless of the performance deficiency, the analyst multiplied both baseline and case conditional core damage probabilities by this value.

The licensee provided a total failure rate for the alternative mitigating strategy of 1.3E-02 in the IPEEE. The analyst's value of 3.23E-02 was calculated by evaluating the potential for equipment failure, as well as a human reliability analysis.
