UNITED STATES
NUCLEAR REGULATORY COMMISSION

SUBJECT: JOSEPH M. FARLEY NUCLEAR PLANT - AUGMENTED INSPECTION TEAM
(AIT) REPORT 05000348/2007010 AND 05000364/2007010

IR 05000348/2007010 AND 05000364/2007010; 9/10-14/07; Joseph M. Farley Nuclear Plant, Units 1 and 2; Augmented Inspection. An NRC Augmented Inspection Team was dispatched to the site on September 10, 2007 to review the failure to close of circuit breakers in the CCW system. Subsequent failures resulted in an extension to the original inspection, with inspectors revisiting the site the week of October 22, 2007. The team identified four issues for inspection followup. These issues are tracked as unresolved items in this report.

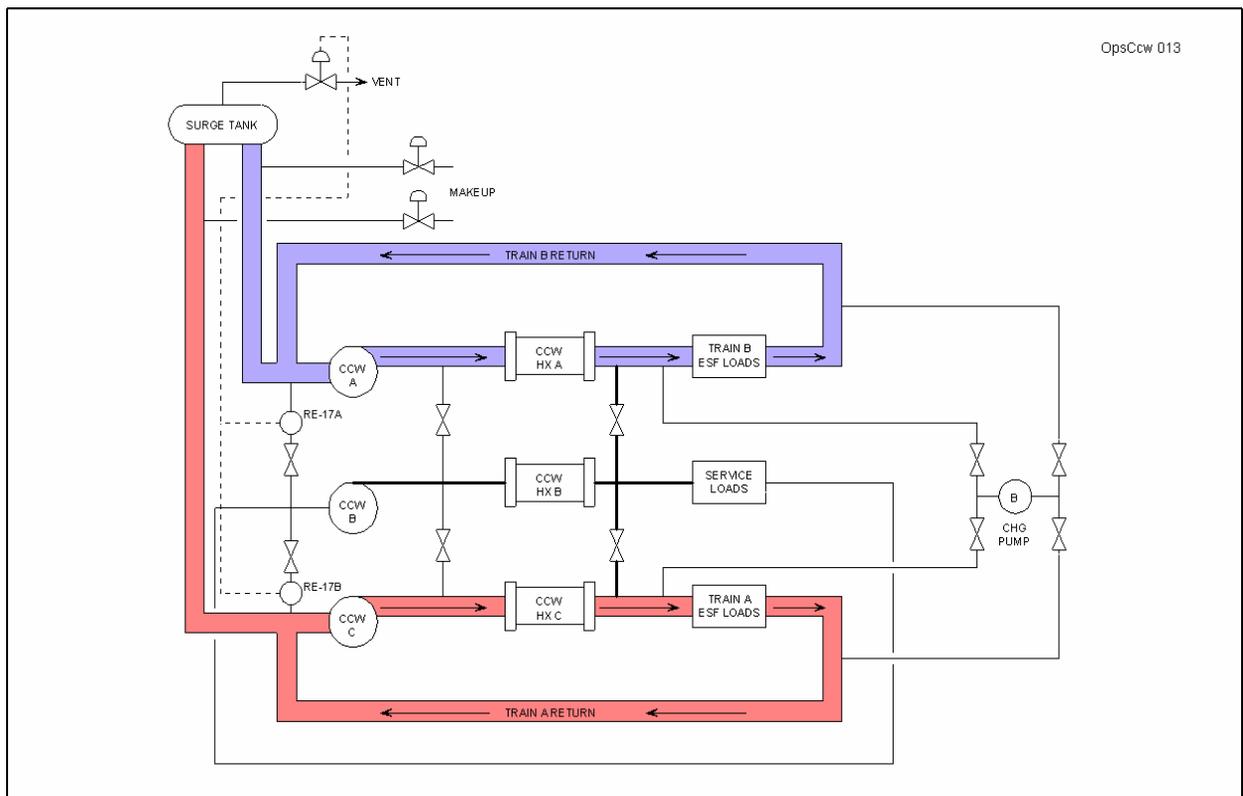
Component Cooling Water (CCW) System Design

The CCW system is used to provide cooling to safety-related equipment. It has two redundant trains. The A-Train is served by the 1C CCW pump which had an Eaton/Cutler-Hammer (ECH) breaker to supply its power. The B-Train is served by the 1A CCW pump which had an Allis-Chalmers breaker to supply its power. The 1B CCW pump is a swing pump which can be aligned to supply cooling water to either train. Prior to the initial breaker failures which prompted the AIT, the licensee was in the process of replacing their older Allis-Chalmers 4160-volt breakers with Eaton/Cutler-Hammer breakers on the CCW and other safety-related systems.
